MERRIMACK RIVER BASIN  
EPSOM, NEW HAMPSHIRE

NORTHWOOD LAKE DAM  
NH 00285

PHASE I INSPECTION REPORT  
NATIONAL DAM INSPECTION PROGRAM

OCTOBER 1978

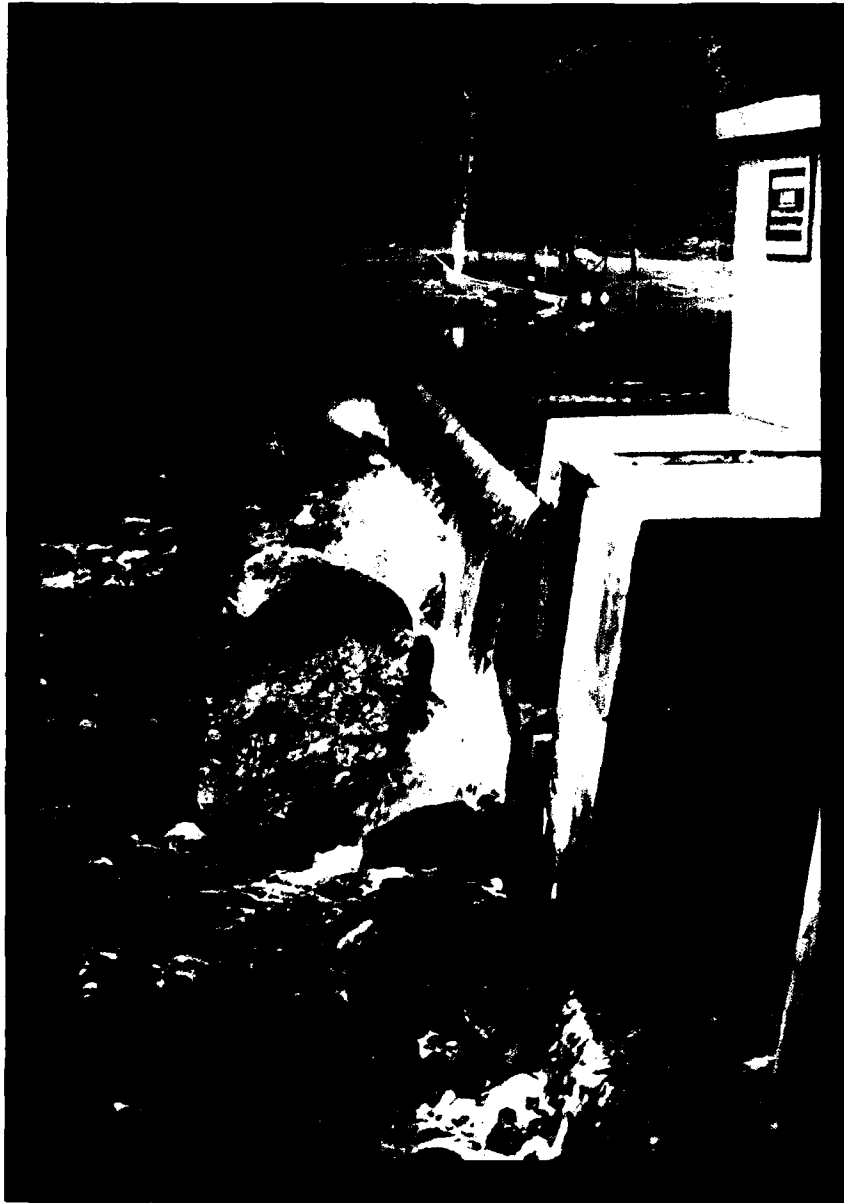
General view of the dam from downstream looking toward the right abutment. The stop plank section and the low level outlet are in the foreground, the spillway section is in the background.
